Ready for the Next Earthquake? Housing Reconstruction in Lombok, Indonesia

VIEWPOINT

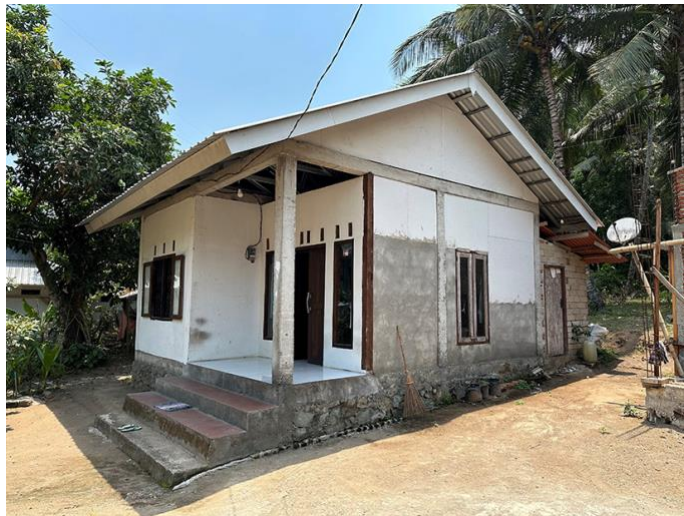
Fig. 1: A RIKO house (photo: lead author, 2023).

Three main 36 square metre (m²) prototype house designs were provided, RISHA (concrete frame and panels), RIKO (confined masonry) and RIKA (timber), but later up to 18 designs were offered, leading to confusion among the communities (Pribadi et al., 2020). Because of the trauma experienced, communities rejected RISHA because of fear of collapse in earthquakes and preferred RIKO or RIKA; RISHA also required sophisticated technology, hence faced production problems (Pribadi et al., 2020). In an earthquake in 2019, several under-construction RISHA houses were

damaged (Lines et al., 2022), damaging the community's confidence and catalysing the rejection of the model. However, to prevent illegal logging the government restricted timber supply, and eventually the RIKO model was widely accepted (Sunarti et al., 2021), using mostly concrete framing and earthquake-resistant construction designs provided by the government (see Fig. 1). A survey indicated that the highest satisfaction was with RIKO among the three types (Widayanti et al., 2020), perhaps because it related closely to local building practices. However, the use of corrugated iron (CI) sheet roofing causes the house interior to become very hot, reported by residents, compared to the previous clay tile roofing, which was discouraged because of its weakness in earthquakes.

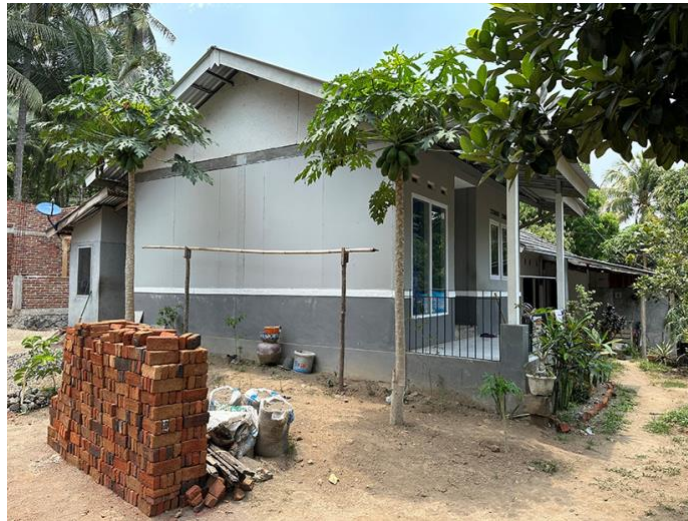
Fig. 2: A RIKO house with a low brick wall and fibre board wall infills above (*photo: lead author, 2023*).

Although the reconstruction program officially ended in 2021 and almost all destroyed and damaged housing had been rebuilt (Lines et al., 2022), many houses were not really completed, evident from field observations in 2023. The widespread RIKO model consisted of a low 90-centimetre outer brick wall with upper infills of fibre-cement, bamboo, timber, etc (see Fig. 2). These somewhat incomplete houses are vulnerable to earthquakes and other hazards. Furthermore, the extensive low-quality construction makes the houses more vulnerable. Field observations also found that in new houses being built by homeowners with their own funds, earthquake-resistant construction guidelines are not being followed. For example, instead of continuous lintels as instructed, discontinuous lintels were found to be built, reducing the safety of the structure (see Fig. 3). Traditionally houses were built of timber, but transition to ‘modern’ materials such as brick and concrete has resulted in low construction quality, evident from the massive devastation in Lombok. There was no provision for inspection and monitoring after project completion, thus, dissemination and promotion of earthquake-resistant construction did not happen, despite the potential demonstration value of the reconstruction house designs. Therefore, there is a need to develop institutional capacity for providing stronger technical support, including support beyond the project timeframe to ensure dissemination of disaster risk reduction principles and safer construction.

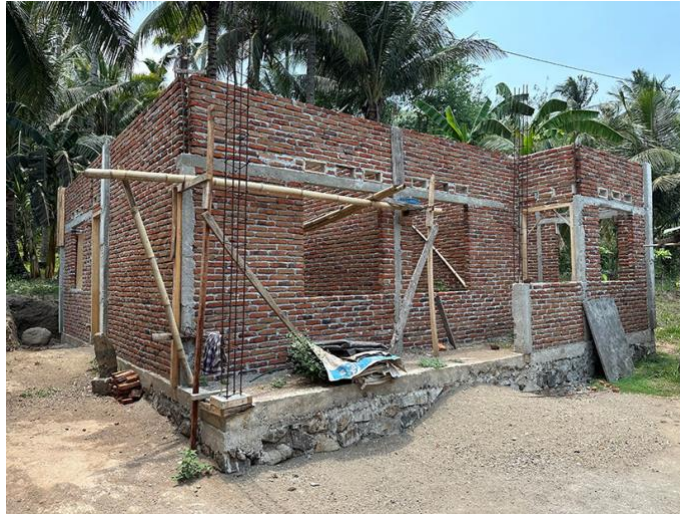
Fig. 3: A homeowner building a house with discontinuous lintels (photo: lead author, 2023).

Inadequate construction quality has been widely reported with divergence between the construction specifications and what was built, and most of the rebuilt houses were not actually earthquake resistant (Tsulis Iq'bal et al, 2022; Lines et al., 2022; Pribadi et al., 2020; Widayanti et al., 2020). Materials such as cement, steel and timber are not readily available, leading to use of low-quality materials and cutting corners (Pribadi et al., 2020). A key reason behind poor construction is the lack of adequate inspections, quality control and monitoring by professionals. There was limited availability of trained and technically competent facilitators appointed by the government (Tsulis Iq'bal, 2022; Lines et al., 2022; Pribadi et al., 2020), indicating the lack of institutional capacity despite the government's readiness to implement reconstruction programs.
